HO-1043

Basil & Reuben Johnson Farm
13145 Triadelphia Mill Road
Private

Maryland Inventory of

Historic Properties Form

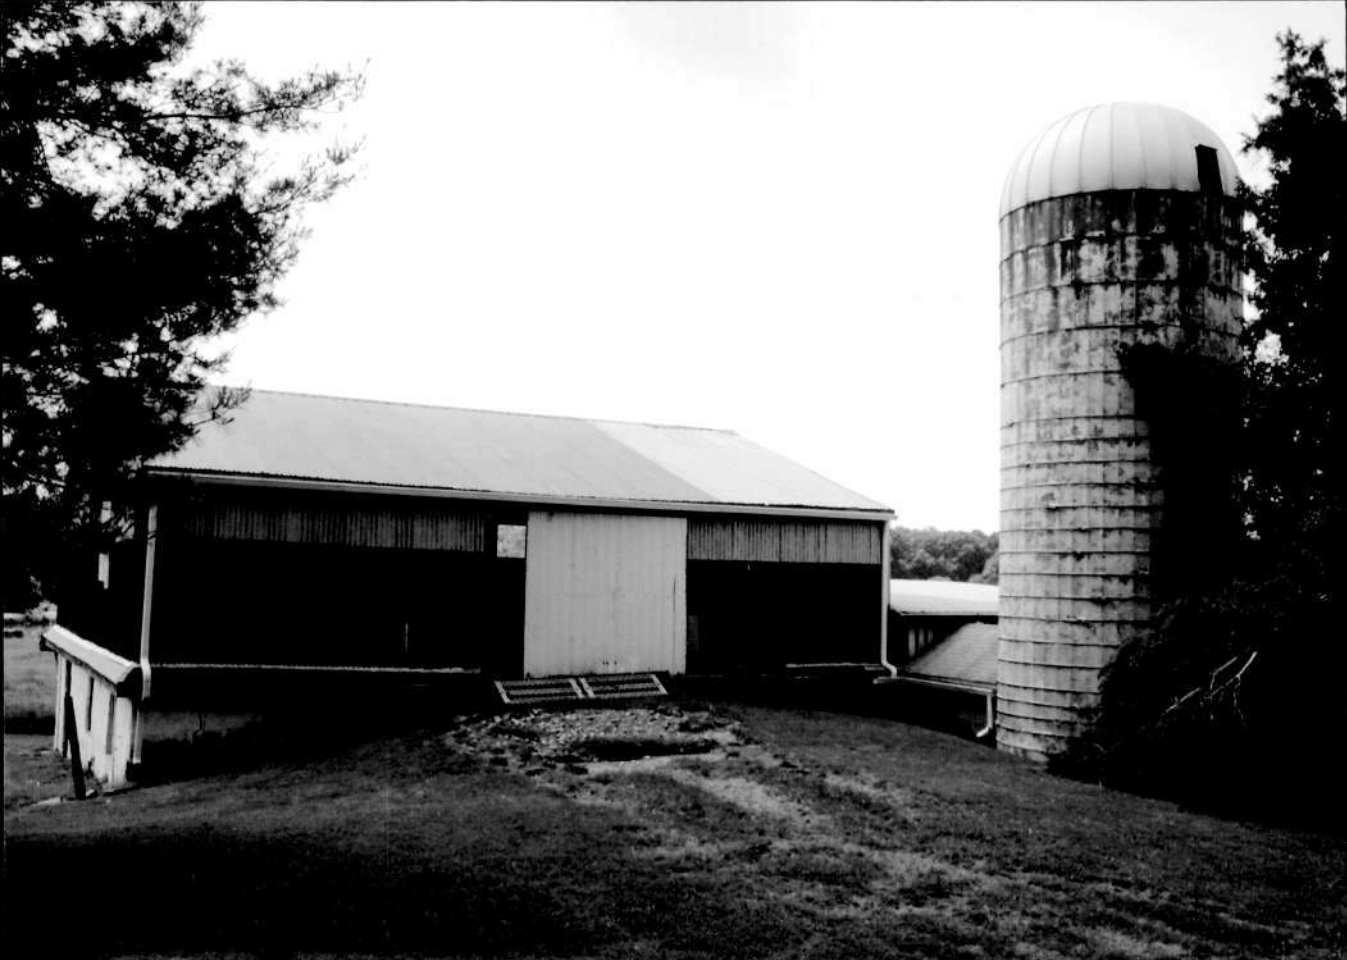
1 of 6

HO-1043_2011-05-25_01
Barn & silo, east & north elevations

Barn + silo, east + north elevations

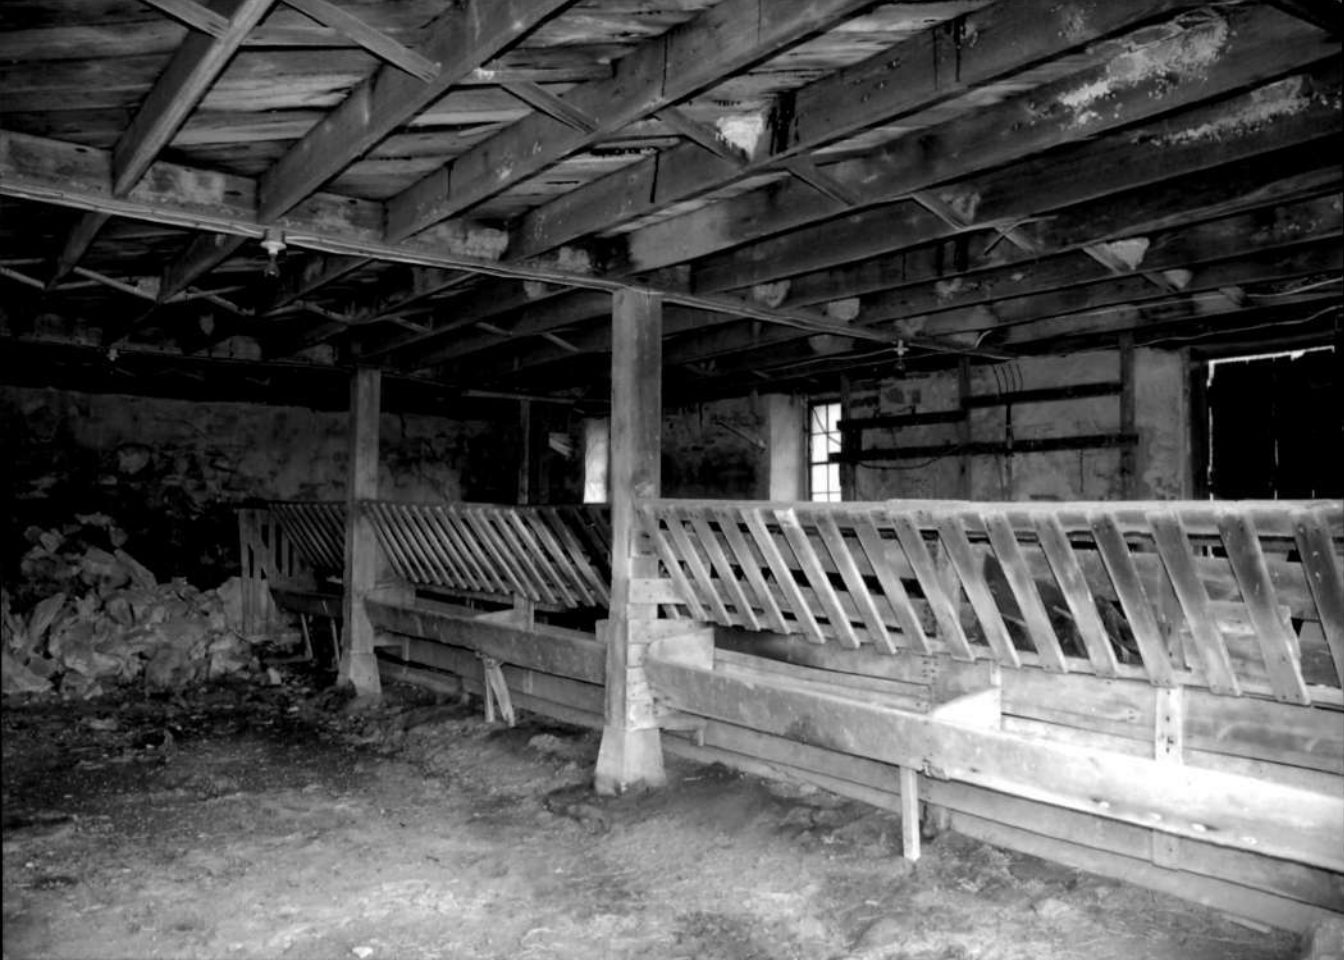
2 of 6

The lower-story interior is three bays divided by two hay racks, with feeding troughs, that run north-south. They are constructed of circular-sawn wood with wire nails. The walls are parged with concrete on the interior. There are 2 by 6 circular-sawn joists with cross-bracing, and diagonally-laid sub-floor above. There are two rows of ganged-together summer beams supported by posts on concrete piers.

HO-1043_2011-05-25_02
Barn interior, lower story, vw. northeast

Barn interior, lower story, vw. northeast

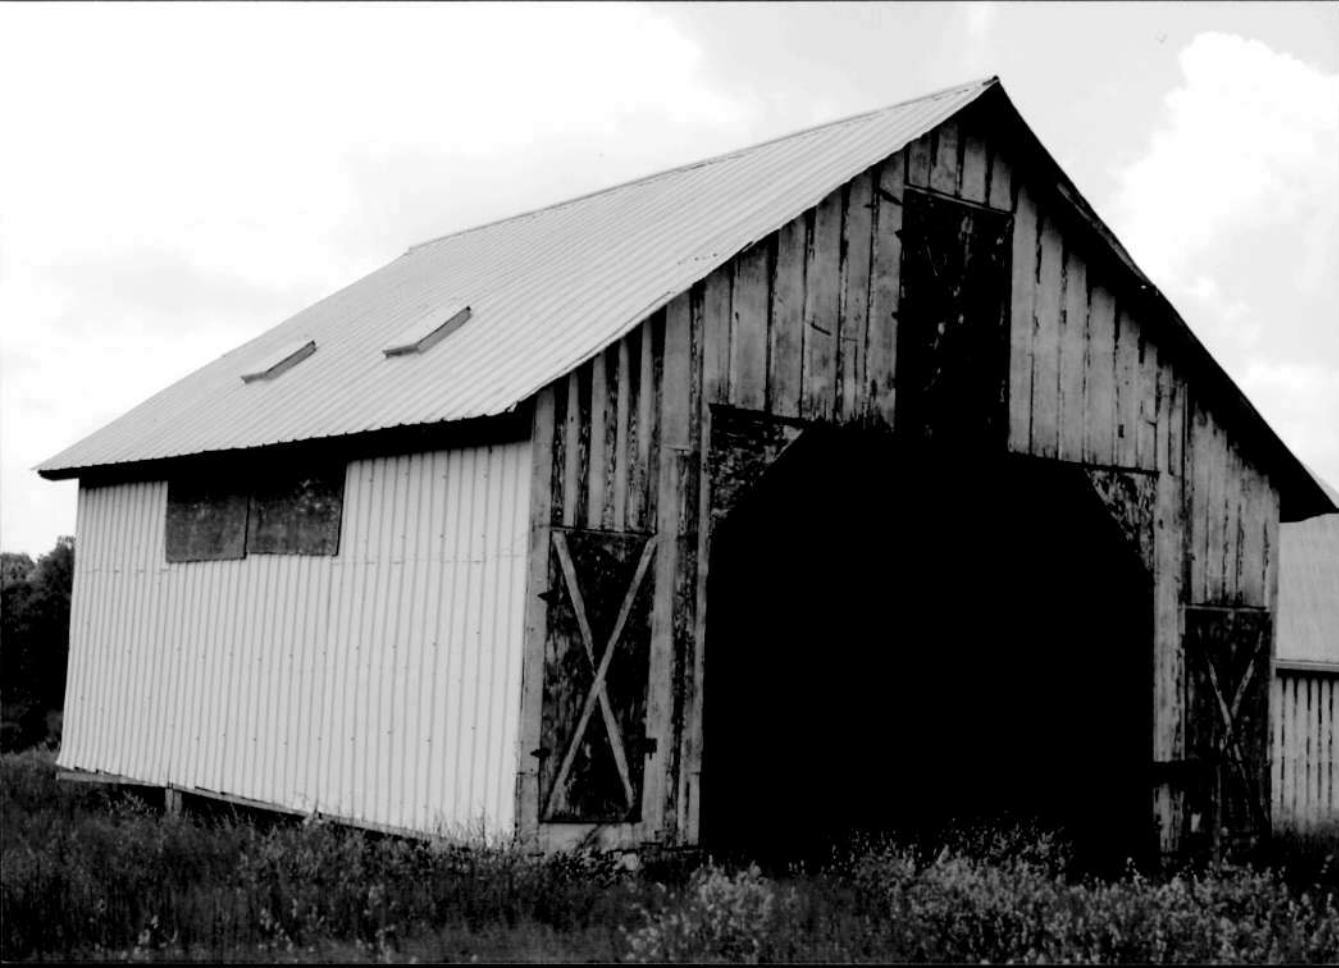
3 of 6

The wagon shed is located about 150 feet southeast of the barn, and is a one-story, three-bay by one-bay frame structure with a rubble stone foundation on the inner two walls and stone piers on the outer walls, some of which have been rebuilt with CMUs. There is circular-sawn board and batten siding, some of which is covered with corrugated metal. The gable roof has inverted-v-seam metal and a northwest-southeast ridge. The eaves are open.

The northwest elevation has a wide opening in the center that never had doors, and has a plywood door in the gable end and in the end bays. The northeast and southwest elevations do not have any openings. The southeast elevation center bay has been closed off with later framing. The south bay has a low hatch on the wall and the east bay has a plywood door. The center of the gable end has a wood six-over-six sash.

HO-1043_2011-05-25_03
Wagon shed, east & north elevations

Wagon shed, east + north elevations

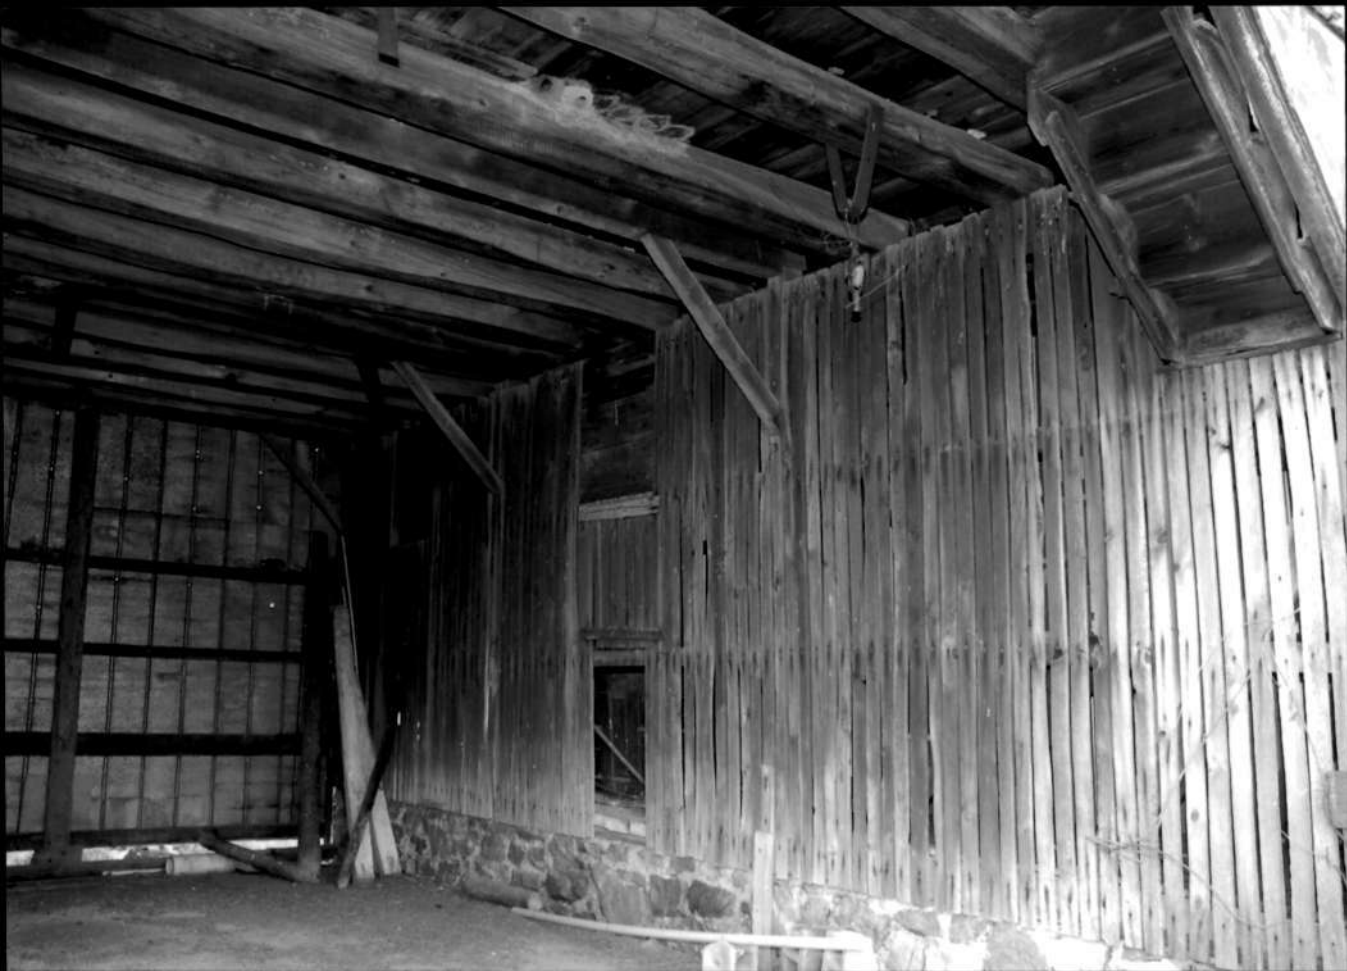
The interior walls are vertical slats for corn cribs on both sides, with several hatches set high and low on each wall, and some of the hatches have been boarded up. The slats are fastened with wire nails. There are circular-sawn joists, most of which are round on the sides, though some are squared on all four sides and have up-braces to them that are mortised and tenoned and pegged. The upper level is floored.

There is a chute from the upper level to the northeast crib. There are stairs in the southwest crib that ascend to the northwest and then turn to the northeast and cut through part of the center of the shed. The doors to the crib are nailed shut. The heavy-timber frame is built of 5 by 6 circular-sawn corner posts and down-braces.

HO-1043_2011-05-25_04
Wagon shed, interior, vw. southwest

Wagon shed, interior, vw. southwest
4 of 6

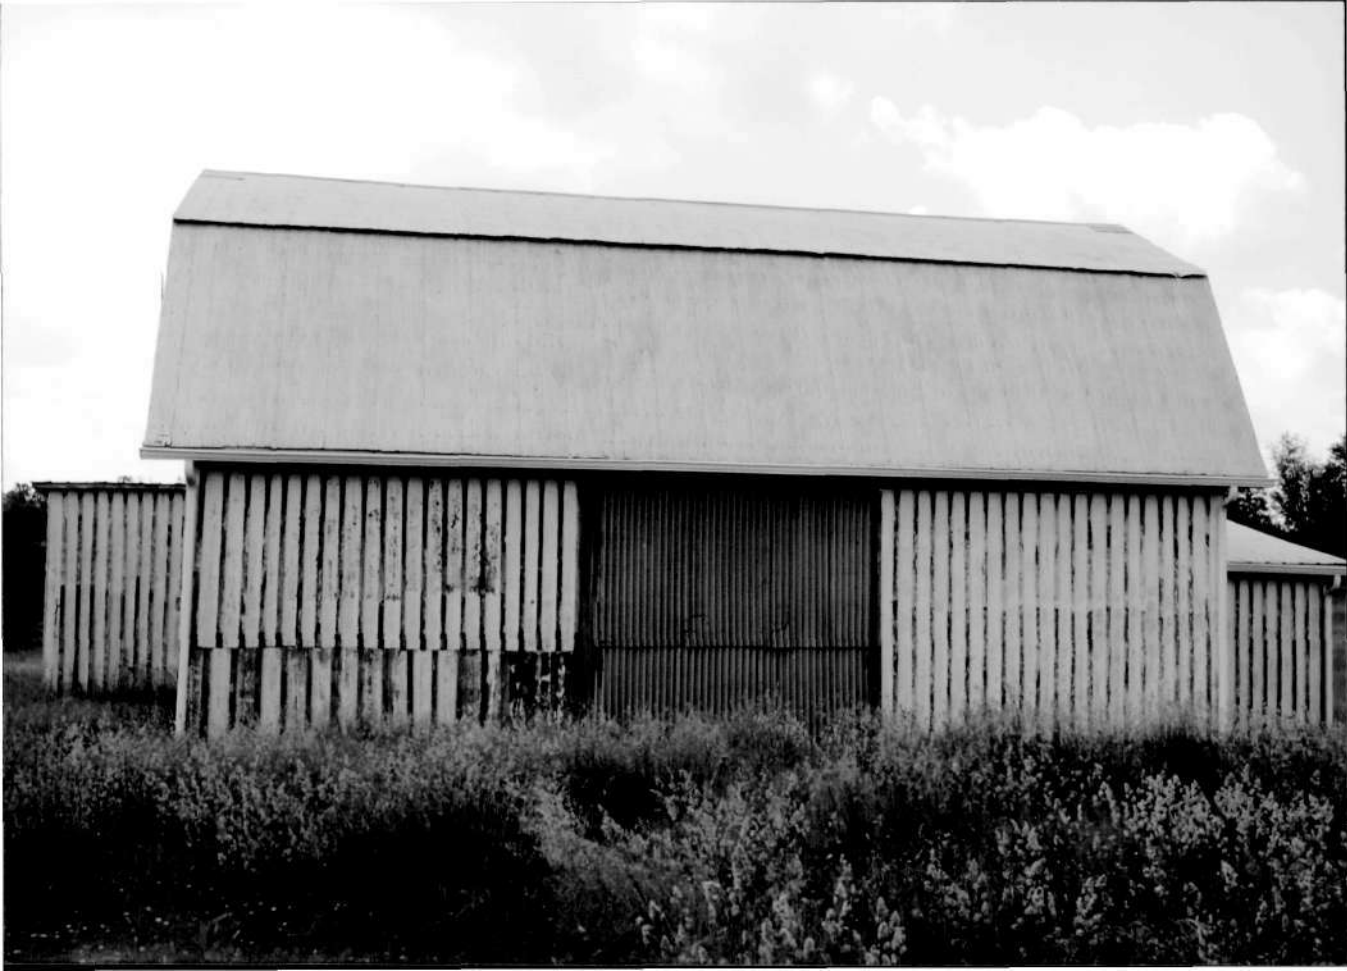
5 of 6

The barrack is located about 30 feet south of the wagon shed. It is a one-story, three-bay by one-bay frame structure with a poured concrete foundation, board-and-batten siding, and a gambrel roof with corrugated metal and an east-west ridge. The north elevation has a door on rollers in the center bay, and it is covered with corrugated metal. There are no openings in the end bays. The east and west elevations have no openings, but there is a one-story, one-bay-square shed added to the west. The south elevation had a door hung on rollers in the center bay, but this is now missing, and there are no openings in the east and west bays. There is a pole-built loafing shed added to the south, and it is wider than the barrack. It has wood hay racks and feeding troughs.

HO-1043_2011-05-25_05
Barrack, north elevation

Barrack, north elevation

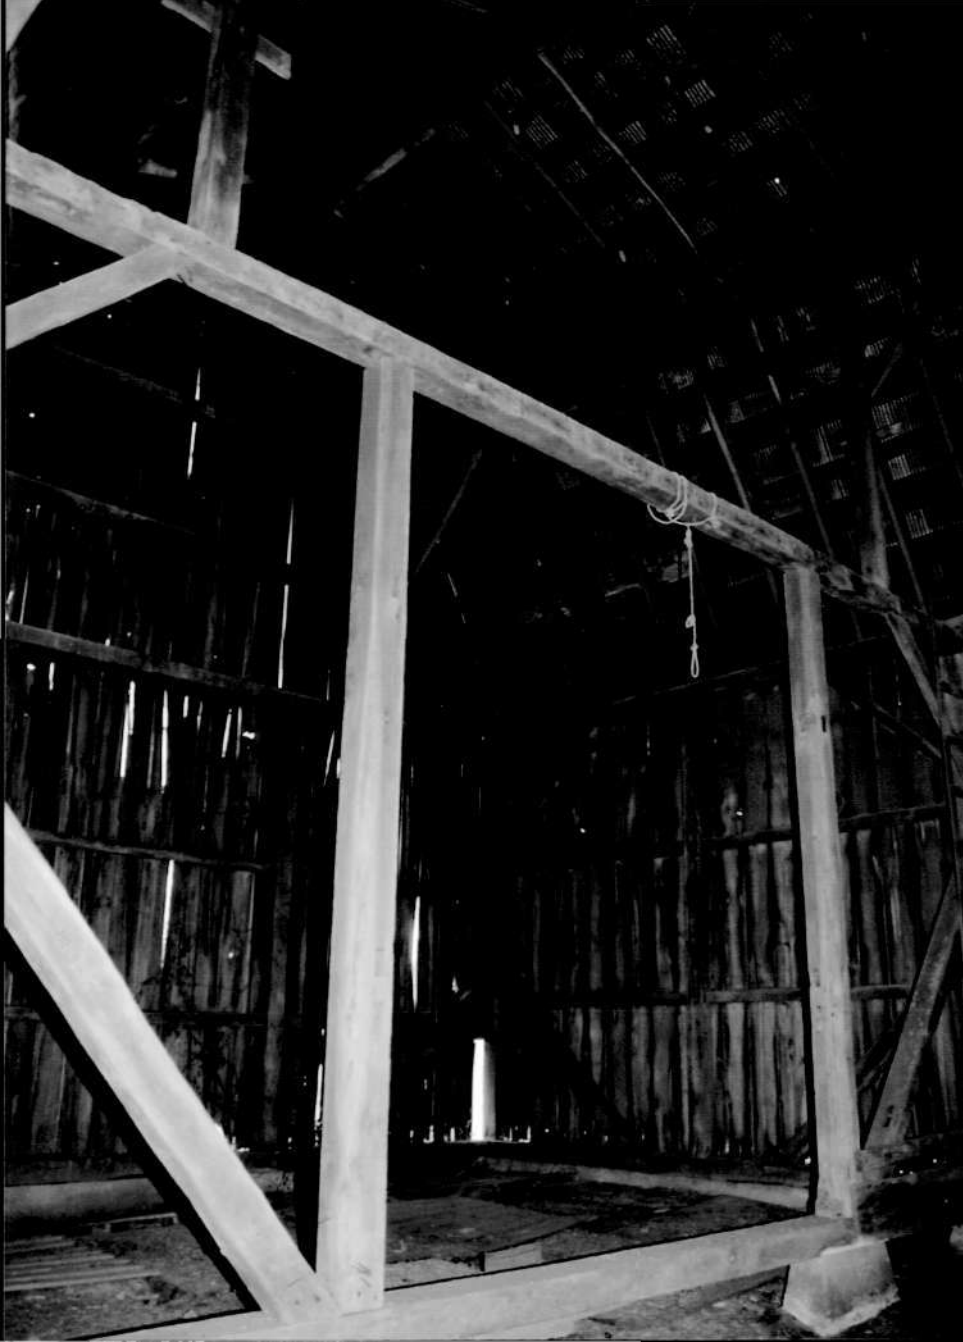
6 of 6

The interior of the barrack has a dirt floor. The braced frame is built of re-used circular-sawn heavy timber that has abandoned mortises all over the framing, and the joints are nailed. There are three bays and the bents have four posts with dropped girts, and up-braces from the posts to purlins under the gambrel ridges. There is a hay track in the ridge with a wood carriage, and the fork is missing.

HO-1043_2011-05-25_06
Barrack, interior, vw. southeast

Barrack, interior, vw. southeast
